GRASSY SPRAIN RESERVOIR

WESTCHESTER COUNTY
NEW YORK

INVENTORY NO 188

PHASE I INSPECTION REPORT
NATIONAL DAM SAFETY PROGRAM

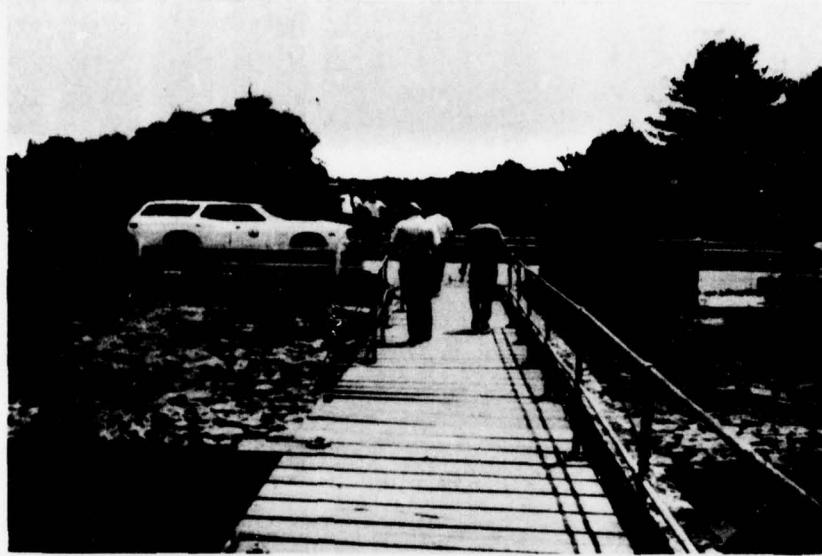
1. View of east side of embankment and riprap.
Picture taken from gate house bridge.
